# Manhole Inspection Summary

Manhole # S07UU\_005MH

Insp Date: **7/19/07 11:14 AM**

**Location** Address: **3709 SPRINGDALE AVE**

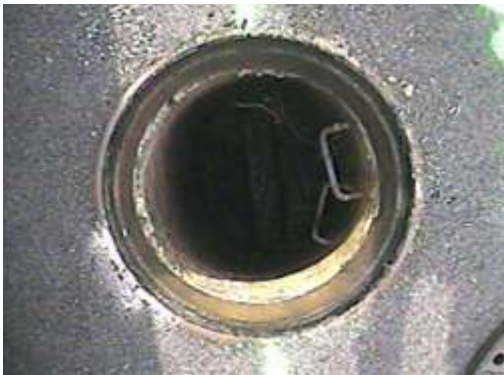
Defect 1

Count: **6** Missing: **1** ☒ **Corroded**

CORRODED STEPS

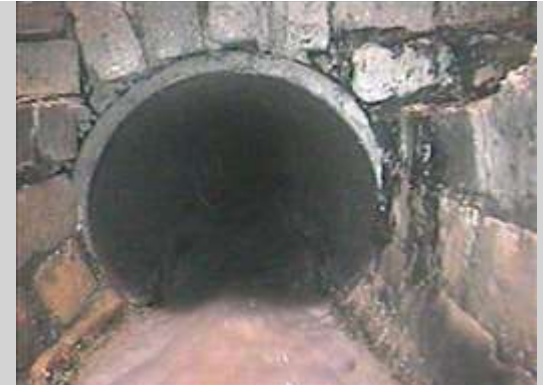
12 O'Clock Outflow

10 in. Circular Gravity Sewer  
Pipe Out @ 12 O'Clock

Pipe Height: (in.) Direct  
Pipe Material: **Clay** ☐ Pipe Lined  
Invert Depth: **11.30** (ft.) Flow Characteristics: **Fast**  
Deposits: ☒ None ☐ Mud ☐ Sludge ☐ Debris ☐ Grease  
Silt Depth: (in.) Deposits Extent:  
Infiltration: **None** Pipe Seal Cond: **Sound**

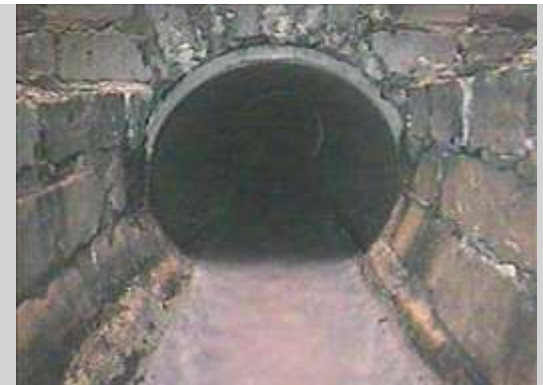
6 O'Clock Inflow

10 in. Circular Gravity Sewer  
Pipe In @ 6 O'Clock

Pipe Height: (in.) Direct  
Pipe Material: **Clay** ☐ Pipe Lined  
Invert Depth: **11.26** (ft.) Flow Characteristics: **Fast**  
Deposits: ☒ None ☐ Mud ☐ Sludge ☐ Debris ☐ Grease  
Silt Depth: (in.) Deposits Extent:  
Infiltration: **None** Pipe Seal Cond: **Sound**
